# THE WATSON'S HOTEL IN MUMBAI

### THE WATSON'S HOTEL IN MUMBAI MATERIALS

### **VARIANT 1: STUDENT** HOUSING

### VARIANT 2: OFFICE **BUILDING**

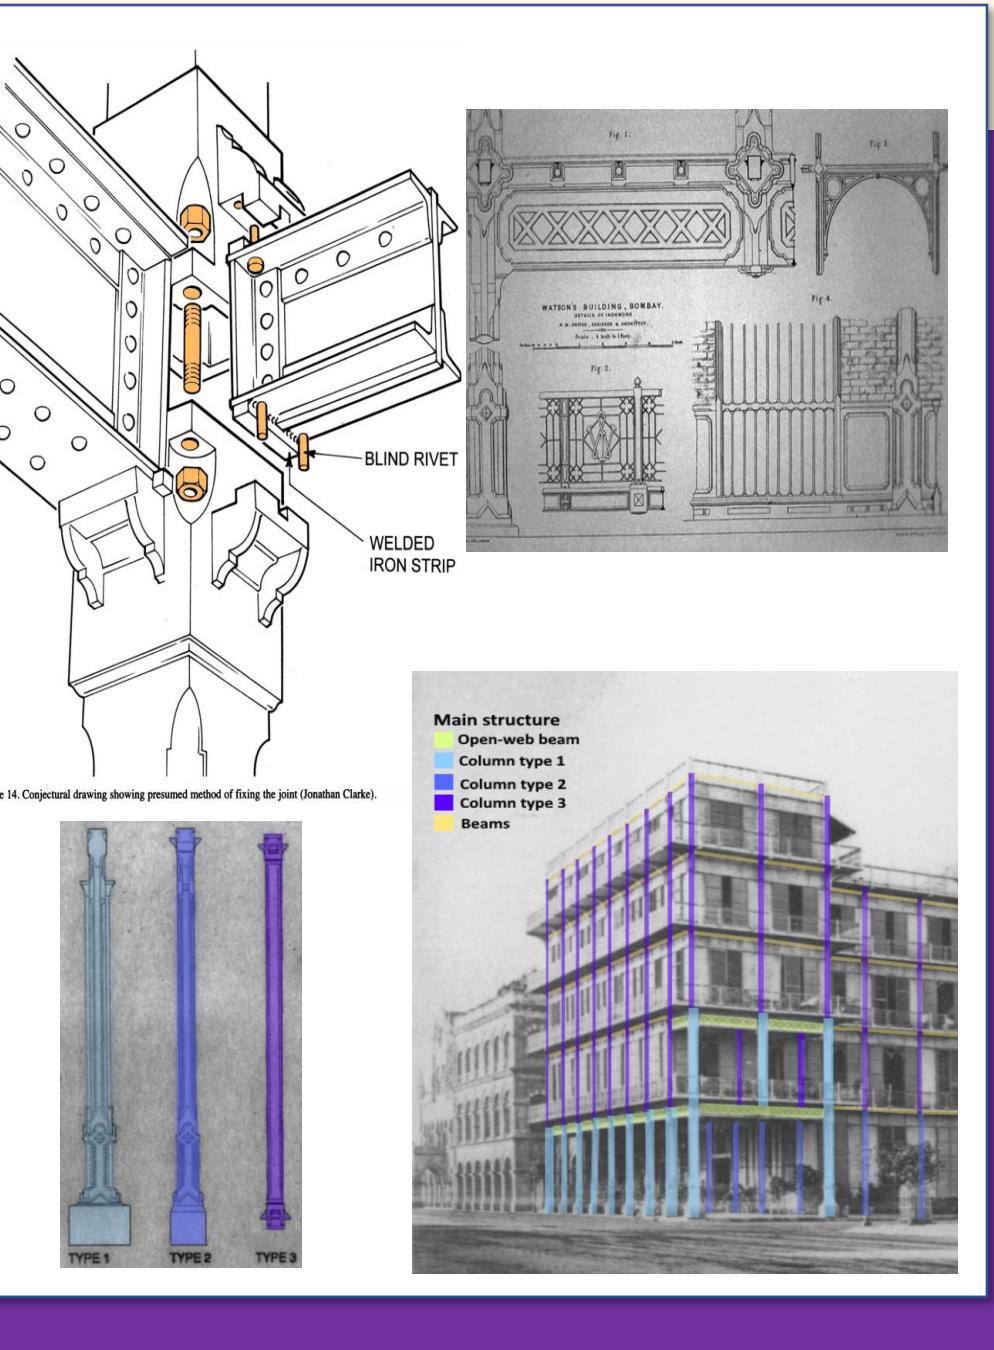
#### Structure

The stability of the building arises from portal frames which consists of the joining of columns and beams. The columns are joined by bolts and have brackets which hold the beams. Small beams are joined to the brackets by blind rivets. Also, strips of iron were attached to the flangs of the beams and were clasped on the brackets of the connecting column. Altogether, a stiff structure remains.

There are some insecurities about the structure caused by incomplete documentation. First of all, it is unknown how the foundation is built. Also, it is unknown how the big beams are connected to the columns. Over time adjustments have been made to enforce the strength of the structure. Among which, extra columns and a reinforced concrete roof. Despite these measurements the structure is currently about to collapse.

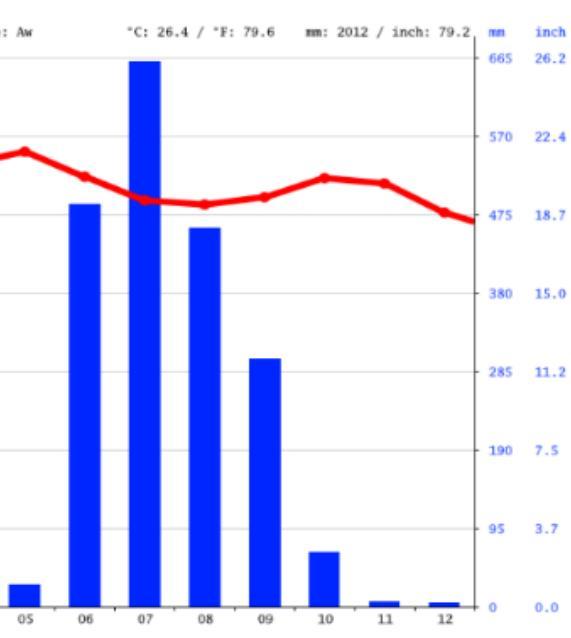
#### CLIMATE GRAPH // WEATHER BY MONTH MUMBAI

#### Climate

In Mumbai reigns a monsoon climate. This climate consists of three seasons among which one with extreme rainfall. The temperature in Mumbai is constantly high with an average temperature between 24 and 30 °C.

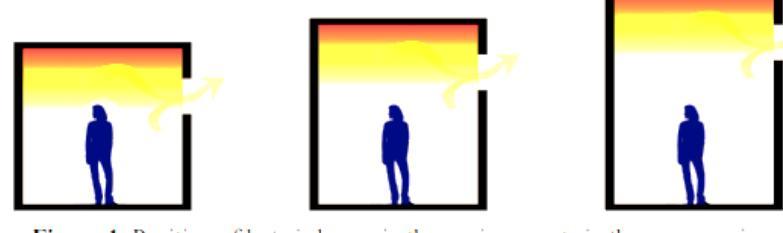
Figure 1. Position of hot air layers in the environments in the upper region.

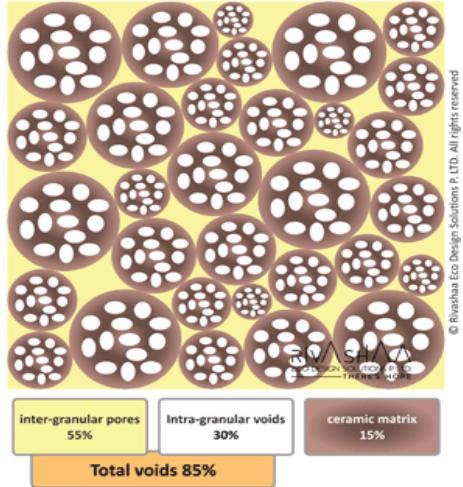
epiction of Inter-granular voids, intra-granular pores and matrix of Expanded Clay Aggregate (ECA) samp

Another interesting option is Expanded Clay Aggregate. This product is produced in India and made by firing clay at 1200 °C. It results in hard round spheres with a size from 0-30 mm. This form of insulation is a good choice for the roof as it can be mixed with binders to make it sturdy enough to walk on.

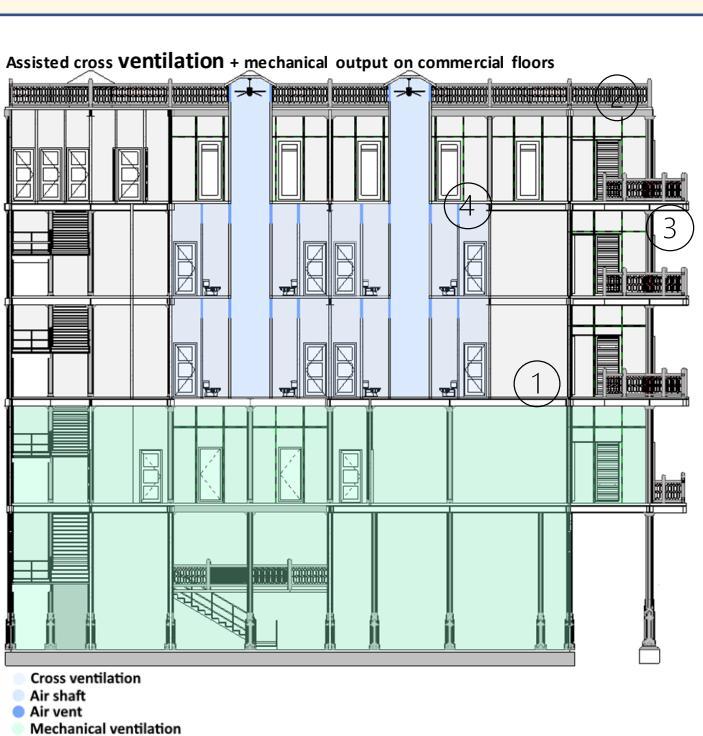
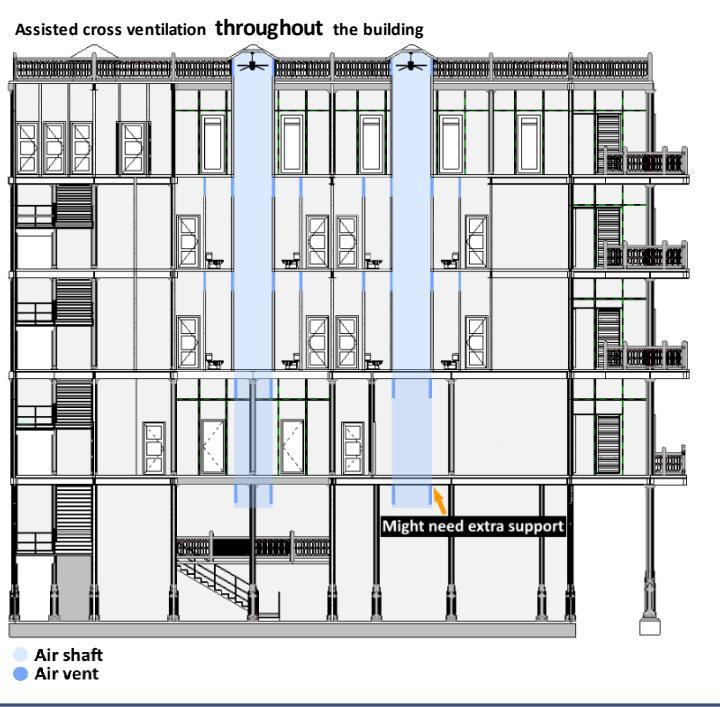
Two different ventilation system are applied in our building design. We chose to do this because there are very different needs for ventilation in the public spaces and the student dorms.

From the third floor up there is assisted cross ventilation. Also, every student dorm has a ceiling fan of its own. As a result of these two measures there is always a wind flow regardless of the wind strength.

These measures are not applied on the ground, instead there is a natural air supply trough louvers in the façade and a mechanical output. We chose to apply this because the air shafts for assisted ventilation are big and limit the freedom of layout. Also, it is expected that these lower floors are more crowded, so a more controlled environment is preferable.

It is also possibly to apply assisted cross ventilation on the commercial floors without decreasing the freedom of layout too much. This can be done by extending the ventilation shafts until about half a meter under the first floor.

This is possible but it must be considered that the shafts may form an obstacle for the stairs and extra support might for the hanging shaft on the ground floor might be needed.

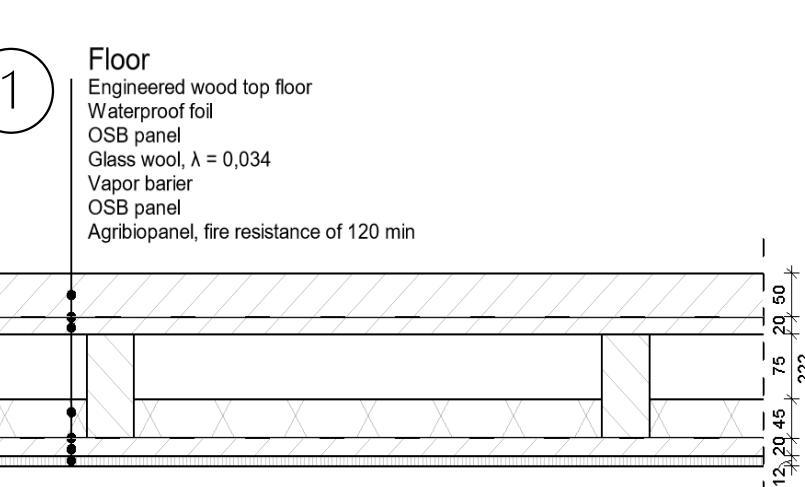
#### DETAILS Note: The details are not scale

In every detail an AgriBioPanel is applied. This panel is an innovative, sustainable alternative for construction boards. It comes in 3 different grades and varied thickness. It is made from 90% straw and 10% binders and comes in 3 grades in varying thickness. Also, it is designed and produced by an Indian company. Because some of the panels are not sensitive to moisture and vapor it is an excellent choice for the hot-humid climate Mumbai has.

The floor consist of a wood construction which is laid on steel beams. It is soundproofed with glass wool. Although glass wool is water resistant it is sensitive to vapor. Because of this a vapor barrier must be

applied. The roof also has a wood construction but has a higher thermal insulation standard because this is advised in the ECBC Residential. The total roof has a U-value < 1,2 W/mK. The insulation consists of glass wool and expanded clay aggregate on top.

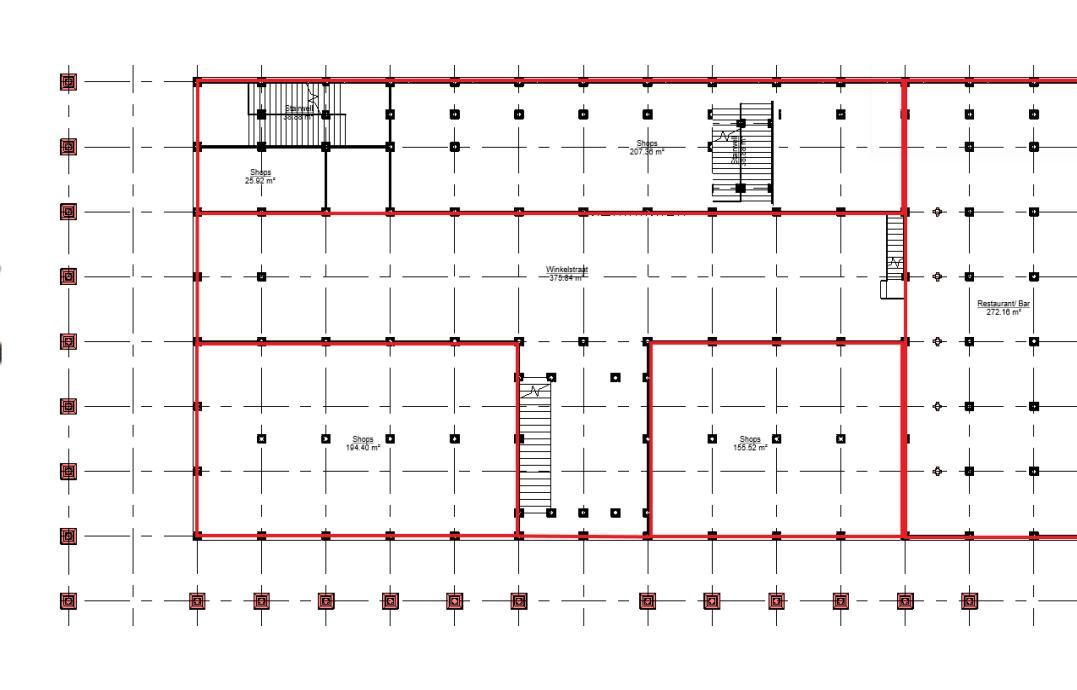
### **FIRE COMPARTMENT**

**Ground Floor** | = fire compartment

Mazzanine Floors = fire compartment = protected Subfire compartment | = Extra protected escape route

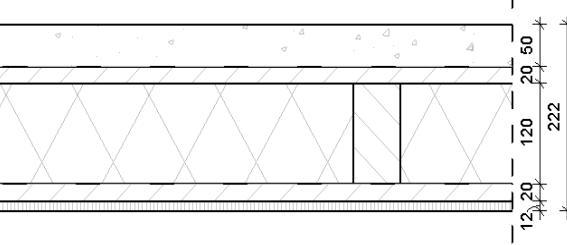
Expanded Clay Aggregate mixed with concrete,  $\lambda = 0,1188$  W/mK

Glass wool.  $\lambda = 0.034$

Agribiopanel, fire resistance of 120 min

The function of the partition wall is to provide sound isolation between rooms and ensure fire resistance. This is provided by the thin layer of glass wool and the AgriBioPanel.

The façade wall is designed to ensure fire resistance and soundproofing. This is done by applying glass wool and the AgriBioPanel. The needed thickness of insulation should be included in further research. Because the building needs soundproofing but not necessarily needs a lot of thermal insulation because of the chosen ventilation system. The hollow brick is placed between the structure. The rest of the build-up is located on the interior side, when applying there must be taken care of interruptions in the isolation. This might be a concern because of the structure.
